Quality Assurance Project Plan
Post Fire Rehabilitation of the Rio en Medio

Submitted by:
Steve Vrooman, Project Manager and Coordinator
New Mexico Environment Department

Surface Water Quality Bureau

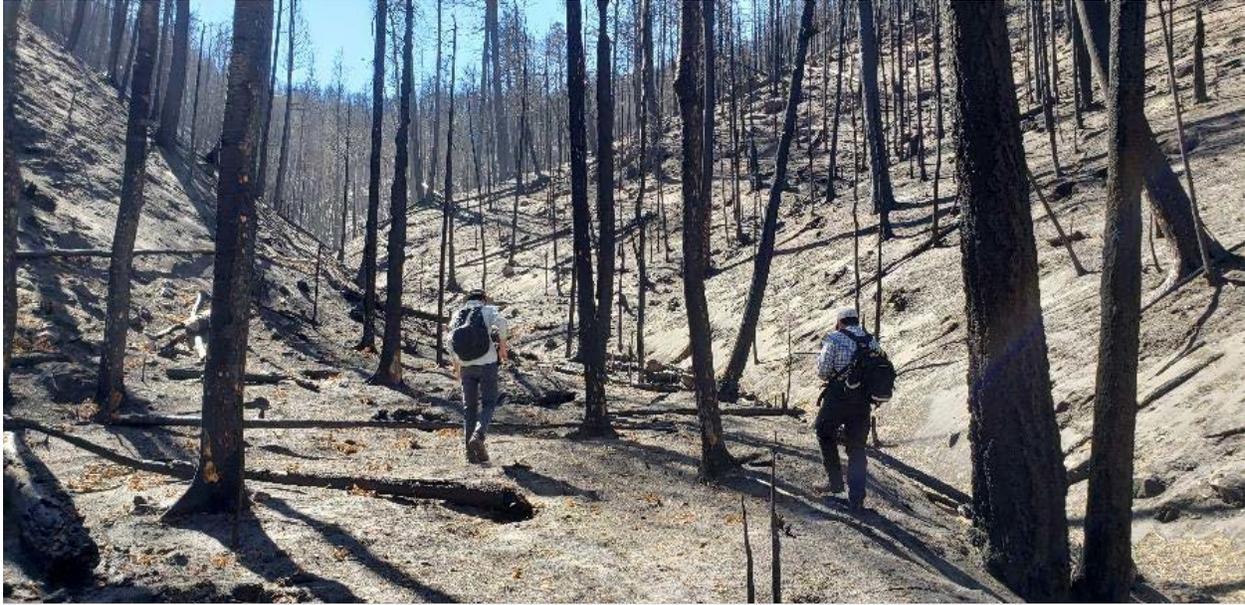
Figure 2. Rio en Medio Burn area

The Medio Fire began on August 17, 2020 on the Española Ranger District in the Sangre de Cristo Mountains above the Villages of Tesuque, Rio en Medio and Chupadero. The fire was started by a natural ignition and burned a total of 4,010 acres. The fire burned between 7,200 and 9,500 feet on steep rocky soils and was managed with a full suppression strategy. The fire burned in a mosaic of severity, with roughly 600 acres of high severity, mostly on north-facing slopes of mixed conifer.

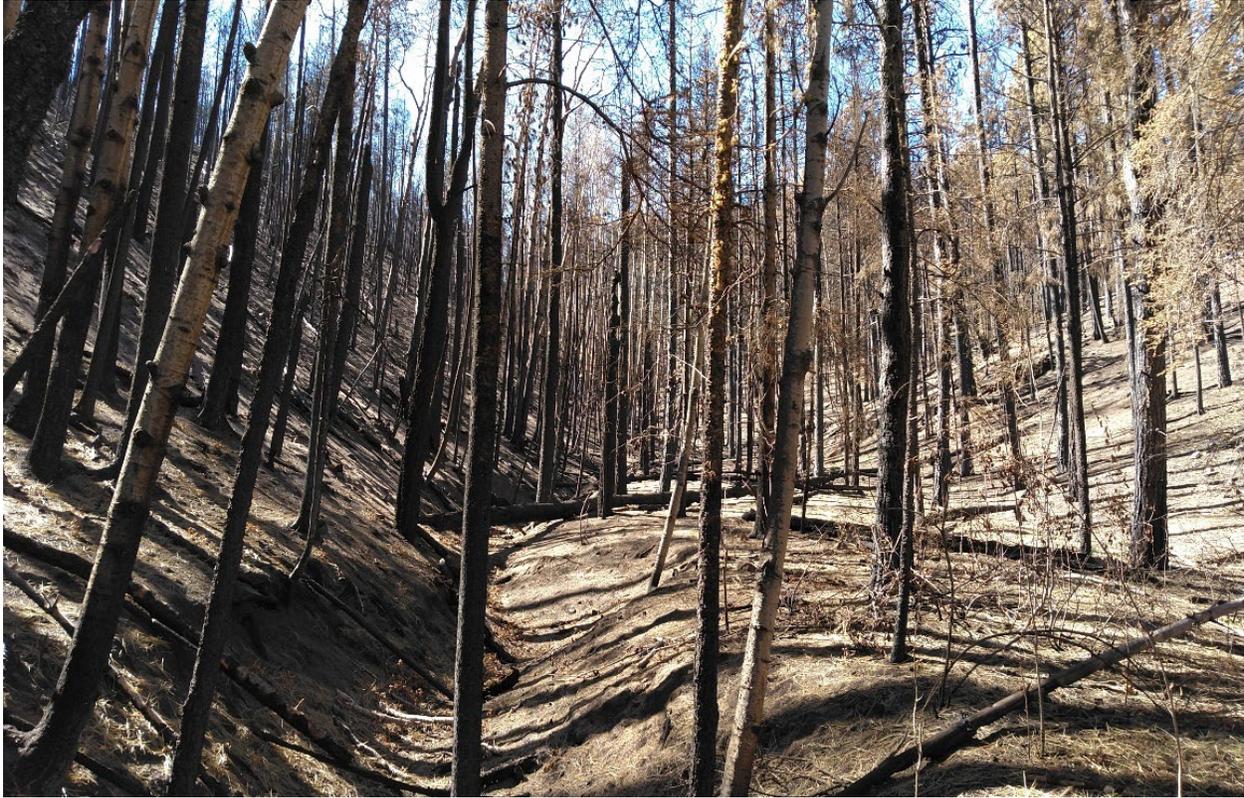
Figure 3. Burned Drainage to Rio en Medio

The goal of the project is to prevent extreme amounts of erosion of ash and soil from flowing into the Rio en Medio that could result following a fire and a rainstorm event. As of now, an intense rain event has not yet occurred on the project area; therefore, the proposed designs are intended to be implemented pre-flood, in order to maximize its effectiveness and prevent erosion before it begins. After 1 or 2 post-fire flood events of great magnitude, gullying will be initiated, and the prevention of erosion becomes more difficult. A pre-fire erosion prevention design is intended to maintain the landform, promote flooding on the floodplains and alluvial fans, and prevent degradation of channels.

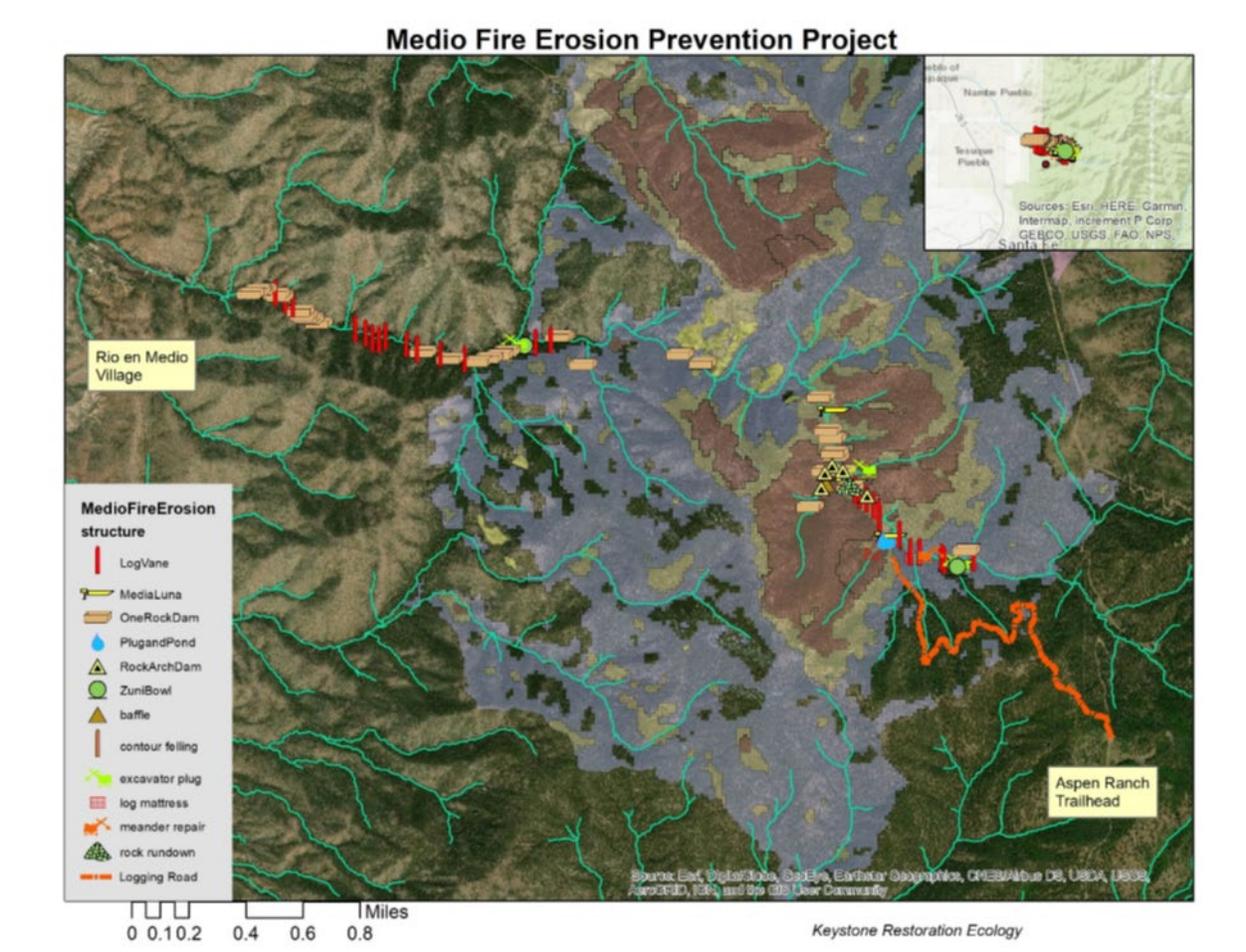
Figure 4. Rio en Medio with Potential Restoration Locations

The project area focuses on the creek in the highest burn severity area south of Aspen Ranch (~35.796240, -105.822720) and in the lower reach of the creek up stream of Rio en Medio (~35.824978, -105.864432). Work on the lower reach will cover approximately 2 miles of channel and the upper reach approximately a little over a mile. Work on the lower reach will be below the waterfalls near Rio en Medio Village to stabilize grade.

All the proposed treatment types and treatment locations are shown in Figure 4 above. Photo-documentation monitoring will be partially driven by the 404 permit. It is likely that key structures will require monitoring using photo-documentation during inspection to ensure that potential failure does not endanger key resources.

Keystone Restoration Ecology will travel to the site and conduct a project area-wide (Figure 4) investigation (field assessment) over the course of one or several days. The field investigation will include data collection for topography, utilizing a laser level for measurements. The topographic data collected in the field assessment will be used to develop a restoration design and rehabilitation plan including treatment type, location and material quantities needed. The topographic data will be analyzed in conjunction with available data (soil types, burn severity maps, aerial and LIDAR imagery) for the project area provided by the USFS in development of design drawings and rehabilitation plan. Though the design and rehabilitation plan are not complete, KRE will utilize a “plug and pond” method for the design and rehabilitation plan. Implementation of the method will reduce sediment (ash and soil) from headcuts and unstable streambanks resulting from fire and promote flooding onto floodplain within the Rio en Medio. Erosion mitigating structures listed in Figure 4 of this QAPP are appropriate treatment options for addressing direct incision and headcuts cause by wildfire, off road vehicles, trailing, and logging (NMED/SWQB 2014). Figure 4 in the Project/Task Description Section identifies approximate location of restoration measures, locations were determined from initial visual assessment of burn areas with the SFNF and KRE. Exact location of restoration measures will determine monitoring locations. KRE will conduct all monitoring for the project. Photo-documentation will be conducted at restoration structures post-construction and will be used to document restoration structure effectiveness. Visual inspection of the watershed restoration measures (erosion control structures) will take place after major flood events and in the Summer 2021 and Fall (2021-2022) after summer monsoon runoff to assess and repair any damage to structures. Visual inspections will be documented with photo-documentation monitoring of each structure that includes multiple photos of structure type,
